STREAMBANK EROSION CONTROL EVALUATION AND DEMONSTRATION PROJECTS (SECTION 32) IN NEW ENGLAND

**HAVERHILL, NEW HAMPSHIRE
NORTHFIELD, MASSACHUSETTS**

**DEPARTMENT OF THE ARMY
NEW ENGLAND DIVISION, CORPS OF ENGINEERS
WALTHAM, MASS.**

MARCH 1977

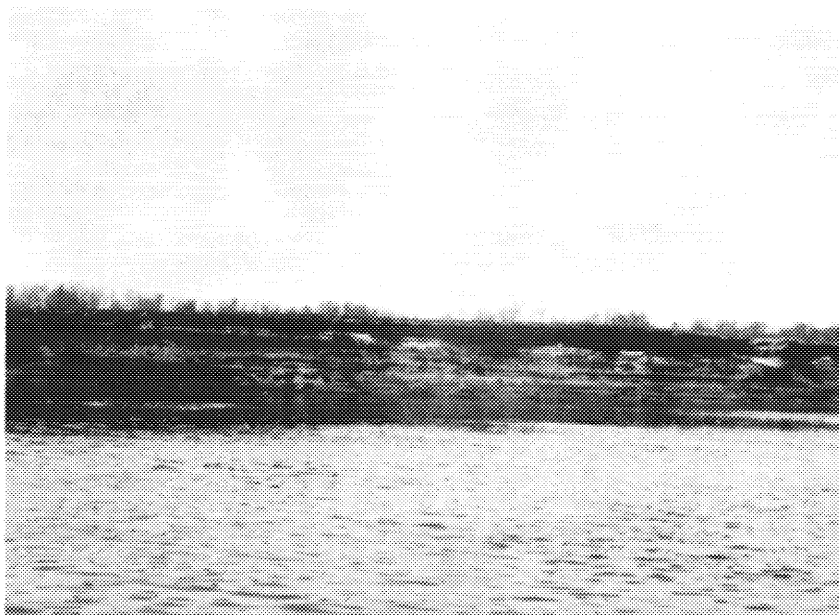
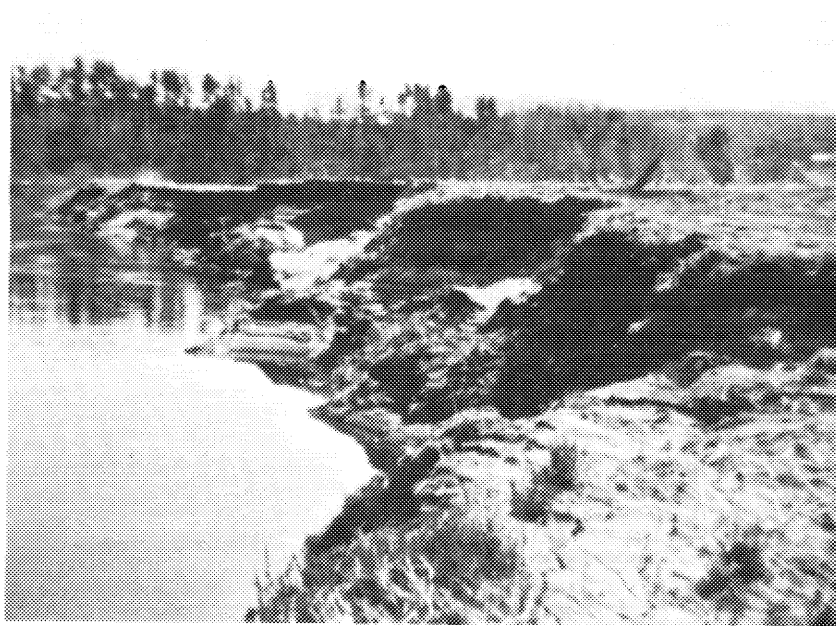
SITE NO. 79-HAVERHILL, NEW HAMPSHIRE

(1) General Description - Area 79 is located in Haverhill, New Hampshire, about one mile downstream from the Newbury-Haverhill bridge, as shown on plate 1. This actively eroding streambank extends to a height of 5 to 15 feet above the normal water surface and is approximately 2,000 feet long. Although this site is located in the upper reach of the pool formed by the Wilder hydroelectric dam, it is significantly affected by open channel flow conditions. The study reach is at the outside of a 70 degree bend in the Connecticut River.

(2) Hydrologic Conditions - Flow conditions at Area 79 are best represented by the records of the U. S. Geological Survey gage located 11 miles upstream on the Connecticut River at Wells River, Vermont (drainage area = 2,644 square miles). The average flow at the gage during the summertime low flow season (July-October) is 3,450 cfs and during the spring snowmelt months (April-May) is 15,635 cfs. The average annual peak discharge has been 33,100 cfs since completion of the last major upstream storage project in 1961. During such an event, high flows overtop the banks which is typical of the upper reach of the Connecticut River. At this particular site, high flows have passed over the top of bank, running down through an adjacent hayfield and rejoined the river at the next channel bend. The river is attempting to create an oxbow which would result in 30 acres of farmland being turned into an island.

The annual mean flow is 4,810 cfs; however, during the day flows may fluctuate from 1,000 to 6,000 cfs due to the operation of upstream power dams. During such normal flow periods the water surface at Area 79 varies from 1 to 1-1/2 feet per day between elevations 386 to 383 feet msl over the weekly period. Under normal flow conditions, local velocities at the toe of the bank have been computed to vary from 0 to 2 fps. During a high flow of approximately 15,000 cfs a toe velocity of 4 fps was measured by a current meter.

(3) Soil Conditions - When inspected on 21 April 1976, the banks ranged from approximately 10 feet above to 3 feet below the water level. The top two-thirds of the exposed banks, except for a foot of sandy silt on the top, consist of a silty medium to fine sand. The lower one-third of the bank is a clayey sandy silt. In the low reaches of the bank, the river had flooded an area around 200 feet across, extending from 150 to 300 feet from the bank. Fresh deposits of silty fine sand varying in depth from a fraction of an inch to several inches were evident along low portions of the entire field.

(4) Protective Measures - It has been observed that during high flows, streamflow is projected against the bank, causing the soil at the toe of the slope to erode. As a result of the removal of this toe material, the bank becomes unstable and large clumps of the upper bank materials break away. An attempt will be made at this area to show the effects local velocities have on the following types of toe protection: (a) 9-inch thick, rockfilled gabion mattress, (b) concrete-filled fabric, and (c) wire mesh and cloth material anchored to the slope. One portion of the reach will not have toe protection. To prevent sloughing of the upper

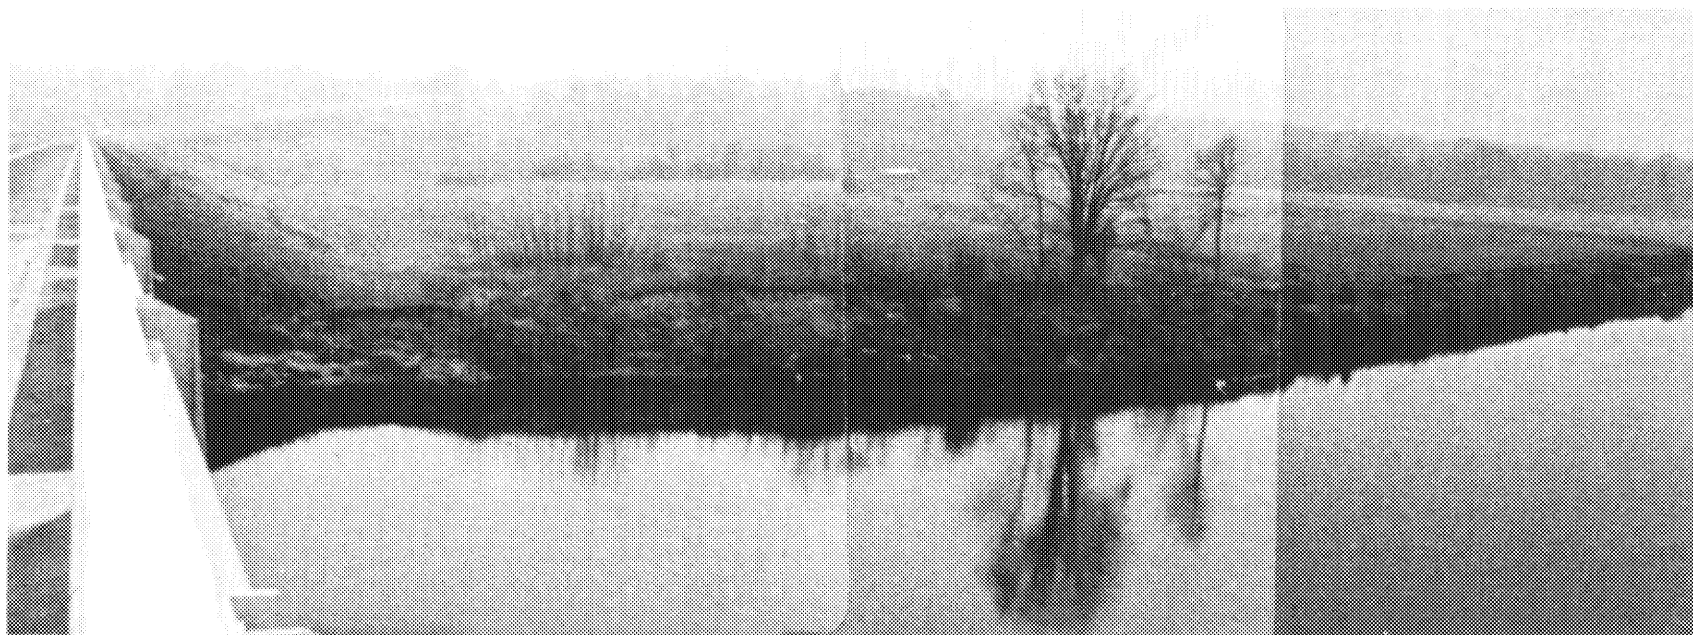
SITE NO. 205 - NORTHFIELD, MASSACHUSETTS

The second site, located in Northfield, Massachusetts, is identified as Area 205 (see photographs). This area was selected as it is on a straight reach of channel and is affected by both normal channel velocities and pool stage fluctuations caused by a downstream power dam. Hydrologic, hydraulic and soil data gathered in the ongoing "Connecticut River Streambank Erosion Study" played a significant role in the selection of these sites. Numerous field investigations have already been made of the 140-mile reach of the Connecticut River which includes both Areas 79 and 205. Finally, both sites are located within a 3-hour drive from the New England Division office, making them relatively easy to monitor.

(1) General Description - This area, located on the east bank of the Connecticut River in the town of Northfield, Massachusetts just south of the Route 10 highway bridge, is shown on plate 1. It is situated about midpoint in the 20-mile long Turners Falls power pool. This actively eroding streambank is approximately 15 feet high, 2,000 feet in length, and lies within a straight section of the 600-foot wide river channel. Stream velocities along the bank were observed to be 2 to 3 fps during a high flow of 50,000 cfs.

(3) Soil Conditions - This area is located along fertile farmland of the mid-Connecticut River flood plain. The tree-lined bank is composed of approximately 1 to 2 feet of clayey sandy silt above a stratum of silty fine sand.
